SURVEY OF LONG-TERM DURABILITY OF FIBERGLASS-REINFORCED PLASTIC STRUCTURES

DOE/NASA/9549-1
NASA CR-165320
TRS 106

Prepared for
National Aeronautics and Space Administration
Lewis Research Center
Under Purchase Order C-39549-D

for
U.S. DEPARTMENT OF ENERGY
Conservation and Solar Applications
Division of Wind Energy Systems

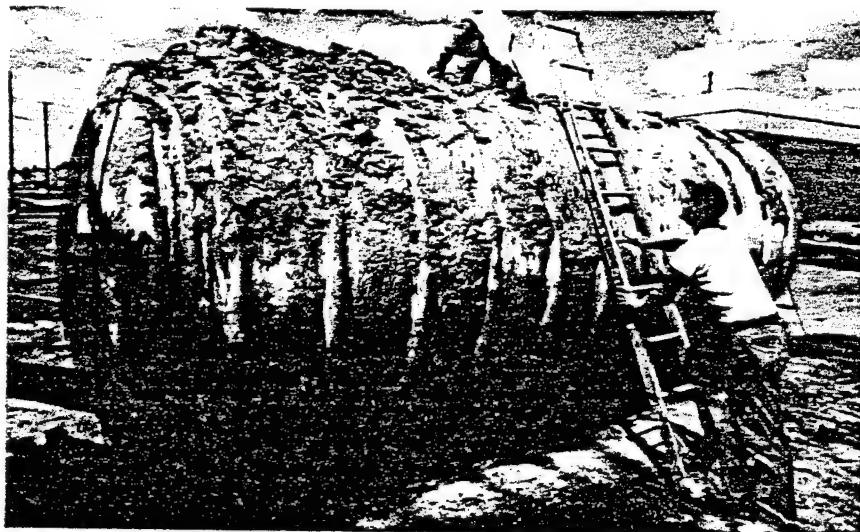
Visual inspection revealed the tank to be in excellent condition. There was no evidence of crazing or cracking of the inner surface. Only a staining of the inner surface from gasoline colorants was found. The outer surface was similarly without any signs of attack. There was, however, a light chalking (due to long-term exposure to moisture) which was easily scrubbed off.

Tank after nearly 13 years. - The second tank, which was installed in Stony Ridge, Ohio, was removed in 1977 after 12 years and 9 months of continuous service (ref. 13). A photograph of the tank after removal is shown in figure 18. The exterior surface of the tank ends and the center joints had a white, somewhat chalky film, which easily scrubbed off with an abrasive cleaner. This surface effect was typical of air-cured fiberglass surfaces exposed to moisture over long periods of time. No areas of cracking or crazing were found on the inner surface.

Figure 18. - Filament-wound fiberglass gasoline storage tank unearthed after
$12\frac{3}{4}$ years of service. (Photo courtesy of Owens-Corning Fiberglas Corp.)

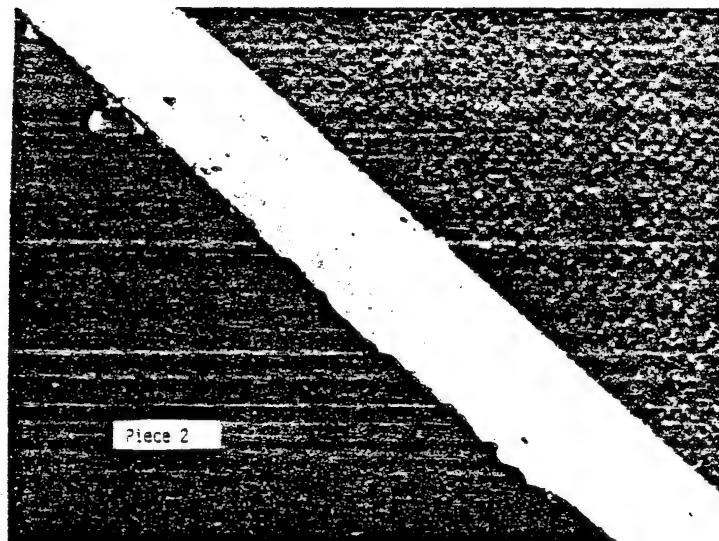
(a) Laminate sections, 1962.

A comparative study of similar tests from these two samplings conducted in 1962 and 1972 is described in reference 14. Visual examination of the removed panels showed no evidence of deterioration due to age or environment (fig. 22). There was no discoloration beyond the first millimeter of thickness, and there was no indication of water or other contaminants penetrating the small number of voids in the laminate.

Figure 22. - Cross sections of hull laminates of
Coast Guard patrol boat after 10 and 19 years
of continuous service. (Photo courtesy of
Owens-Corning Fiberglas Corp.)
